WATER LEAKAGE ON BRISK AIR TYPE HEAT PUMPS AND AIR CONDITIONERS

**DOMETIC & DUO-THERM
AIR CONDITIONING
BULLETIN A24/8B
March 1998**

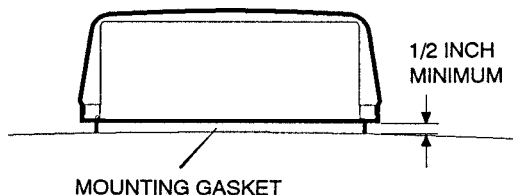
FIG. 3

DO NOT OVER-TIGHTEN the mounting bolts as you may damage the unit base.

When attaching the unit to the roof, tighten the mounting bolts only enough to compress the mounting gasket to **1/2 inch** (40 inch pounds of torque).

Once the unit has been installed, the mounting gasket will retain its installed thickness. If the unit is removed for inspection or service, avoid a future problem by installing a new 14" x 14" gasket (Part No. 3100247.000) when you reinstall the unit.

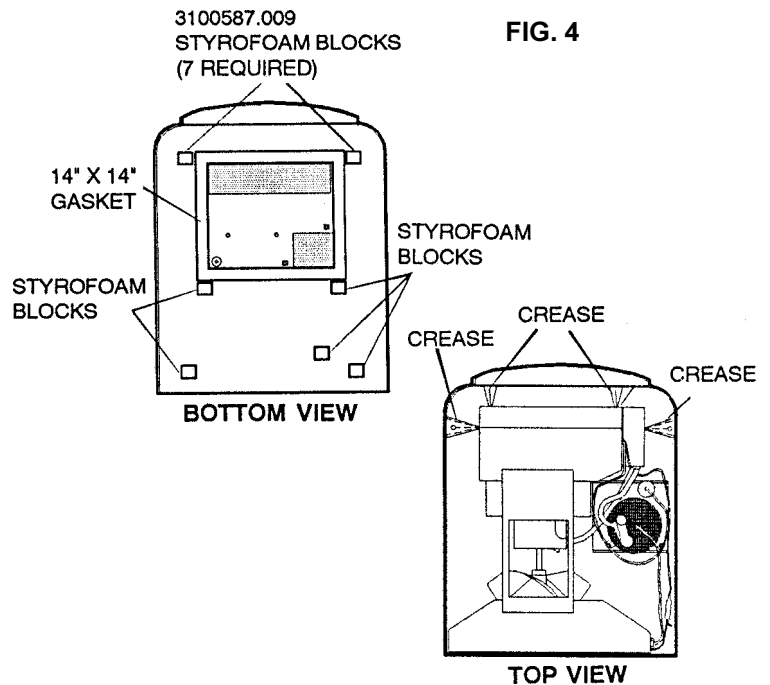
FIG. 4

- 1) Seven styrofoam blocks have been placed on the underside of the base pan. The styrofoam blocks provide an even support for the base pan which prevents it from bending and warping during installation. Over-tightening of the mounting bolts described in **Corrections Step 1.2**, can cause the styrofoam blocks to act as a wedge and force the edges of the base upward. (See Figure 4).

- 2) The rolling and bending of the base pan caused by over tightening of the mounting bolts will let the plastic drain pan pull away from the sealant. Water can flow through the gap between the plastic drain pan and sealant. The water becomes trapped under the plastic drain pan and can enter the interior of the RV through screw holes, etc.. It may be possible to remove the unit and straighten the base pan; however, if the plastic drain pan has pulled away from the sealant it may not reseal. In those cases the entire base pan will require replacement.

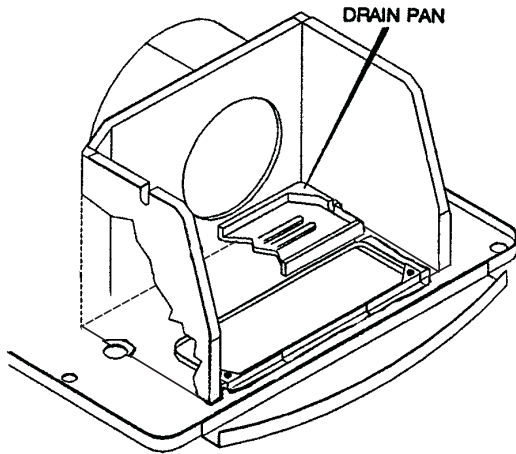
Inspect the drain pan for broken lip, cracks, and plugged outlets. Be sure the drain pan is sealed to the base and look for water trapped under the plastic drain pan. Pressing on the center and edges of the plastic drain pan will move air bubbles that can be seen under it. Breaks, cracks or loss of seal between the plastic drain pan and the base will require replacement of the entire base pan on the unit. Cleaning of the drain outlets will correct problems with water that is trapped on top of the drain pan.

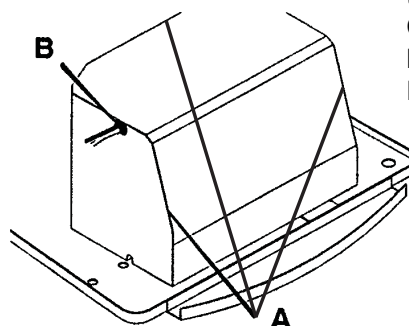
FIG. 6

During high humidity conditions (80% or higher), the blower can suck outside air into the evaporator bulkhead. This air contains large amounts of moisture that will condense on colder surfaces.

Check completely around the evaporator coil cover to be sure it has an airtight seal to the evaporator bulkhead. Look for loose screws that secure cover to the evaporator bulkhead. (See "A" of Figure 6). Check putty sealant around area that refrigerator lines enter the evaporator bulkhead. (See "B" of Figure 6).
