Alignment and Adjustment Of The Horizon Front Bar Gap.

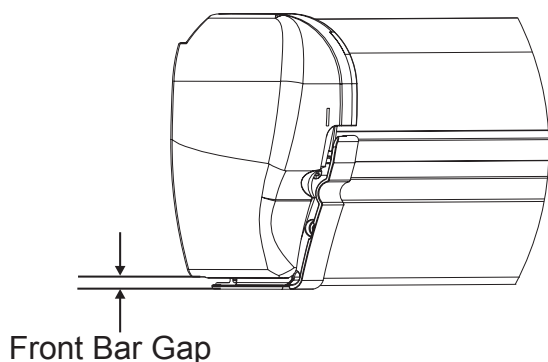
FIG. 1

1. Perform these recommendations if:
 - a. The stretching and/or wear of the fabric or the initial material condition affects the front bar closure. (See Fig. 1)
 - b. If the front bar gap exceeds 3/16", alignment and adjustment is recommended. (See Fig. 1)

1. Using the manual crank extend canopy 3 feet from coach.
2. Mark position of the wrist bracket in front bar with a pencil. Loosen the hex nut holding the wrist bracket to the front bar. Once loose, slide wrist 1/8 of an inch towards the end of the front bar along the front bar slot. Repeat adjustment in increments of 1/8 of an inch as needed. (See Fig. 2) If gap worsens, stop and return wrist bracket back to original position and proceed with step C. If front bar gap is still not acceptable after three adjustments, then proceed with **step C Arm Adjustment Using Foam Pad**. (See Fig. 1 & 2)
