# REFRIGERATION REFRIGERATOR

**Absorption Refrigerators**  
Service Bulletin

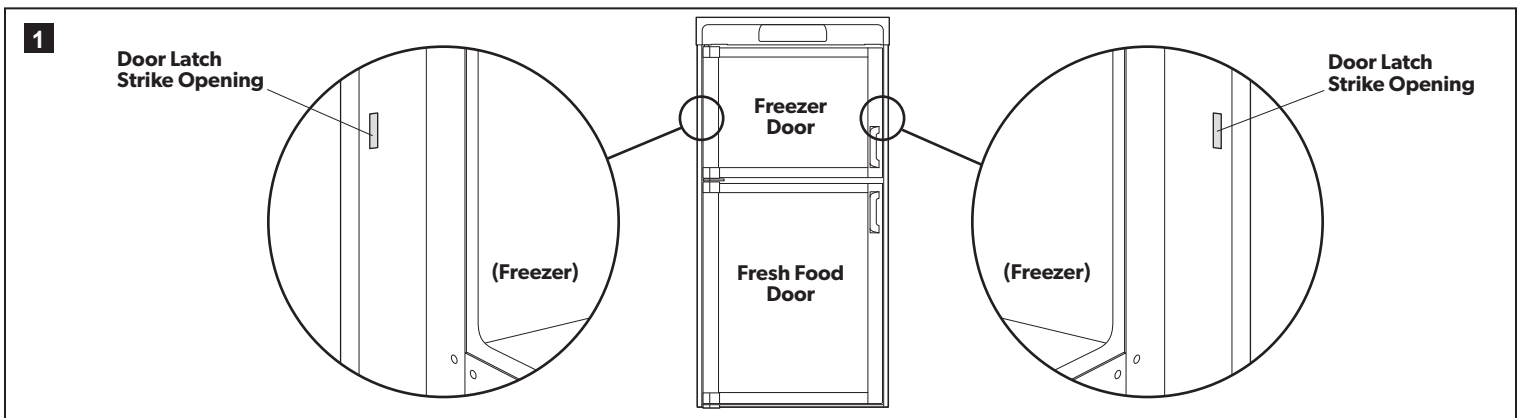
## Identifying the door latch strike openings

The visual cosmetic defect is that extra door latch strike openings have been punched in the refrigerator frame, and during the assembly process the extra door latch strikes were not installed (please see the illustrations below.) The foam sealing strip, required by ANSI/NFPA 1192 and ANSI Z21.19, is provided to seal the refrigerator against the cabinetry when it is installed into the RV. Although the omission of the door latch strikes leaves small cosmetic openings that can be seen visually, the foam sealing strip located behind the door latch strike openings at the freezer provides a seal to maintain complete separation of the combustion system from the interior atmosphere of the recreational vehicle, as stated in ANSI/NFPA 1192.

The repair that will be made on these refrigerators will be to install door latch strikes with a screw and an additional length of adhesive-backed foam strip. The repair kits will be bulk packed with these parts and instruction sheet(s) showing the proper steps for the repair.
