Absorption Refrigerators
Service Bulletin

USA & Canada

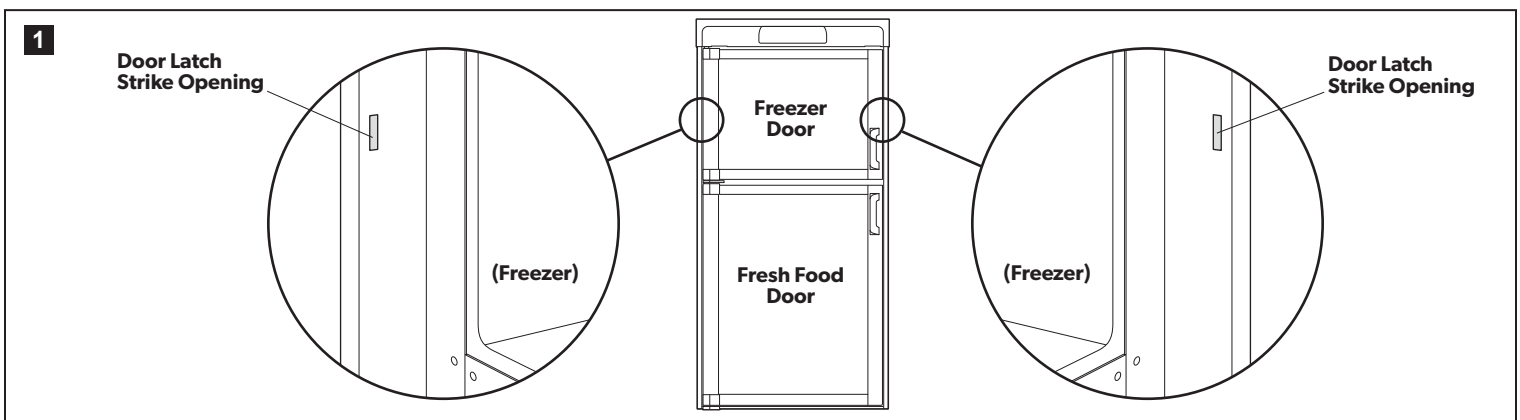
Identifying the door latch strike openings

The visual cosmetic defect is that extra door latch strike openings have been punched in the refrigerator frame, and during the assembly process the extra door latch strikes were not installed (please see the illustrations below.) The foam sealing strip, required by ANSI/NFPA 1192 and ANSI Z21.19, is provided to seal the refrigerator against the cabinetry when it is installed into the RV. Although the omission of the door latch strikes leaves small cosmetic openings that can be seen visually, the foam sealing strip located behind the door latch strike openings at the freezer provides a seal to maintain complete separation of the combustion system from the interior atmosphere of the recreational vehicle, as stated in ANSI/NFPA 1192.

The openings in the refrigerator frame from the missing door latch strikes at the freezer are located at a height far above the external refrigerator sidewall vent openings in the refrigerator ventilation and combustion compartment. Any combustion products produced by the refrigerator will exit to the outside of the RV through those vent openings, and prevent any build-up of combustion particles to the level of the extra door latch strike openings. Therefore, this visual cosmetic defect does not result in a safety risk to any occupant of the interior atmosphere of the recreational vehicle.

The repair that will be made on the refrigerator is to install an adhesive backed cover over the two door latch strike openings. The repair kit will be single packed (3316893.990) as one kit or bulk packed (3316893.991) in a quantity of twenty five kits. One kit will consist of an instruction sheet and four adhesive backed covers. There are two extra adhesive backed covers provided in case of an improper application.
