9200 Awning Motor End Cap Rivet Service Bulletin

Model	Serial Number Range
All 9200 Series Awnings	Serial Numbers prior to #s starting with 829

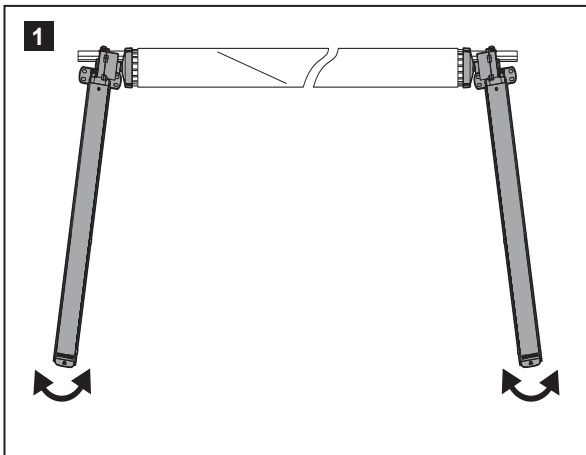
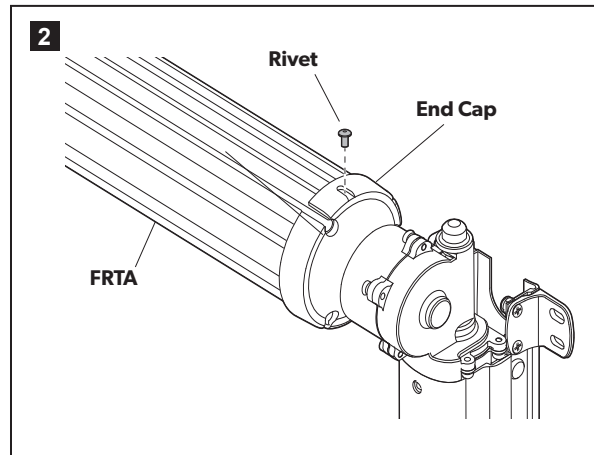
Dometic has identified a **nuisance issue (not safety-related)** that could occur during the installation process on the new Dometic 9200 Series Awning. This issue can potentially occur when the awning assembly is being handled or attached to the RV. If the installer separates the two awning arms from an aligned and parallel position, creating a deflection of more than 12 inches between the arms, one or more of the rivets securing the motor end cap to the fabric roller tube may shear. This can occur on all Dometic 9200 Series Awning models with serial numbers starting with 829. The fault code is 399 – 80 and the flat rate is 0.3 hour. Please call the Dometic Technical Service Department at 1-800-216-5115 opt. 6 for assistance with this issue.

- To correctly handle and install the awning assembly, ensure that the awning arms maintain an aligned and parallel position until the awning assembly is properly secured.

- If the rivets securing the end caps shear during handling or installation of the awning assembly, contact Dometic to obtain the stainless steel rivet kit (part number 308171.021) and complete any repair activities as needed.
